# ANNUAL REPORT FOR 2002

Deer Creek Mitigation Site  
Carteret County  
Project No. 6.16901T  
TIP No. R-2105 WM

Prepared By:  
Office of Natural Environment & Roadside Environmental Unit  
North Carolina Department of Transportation  
December 2002

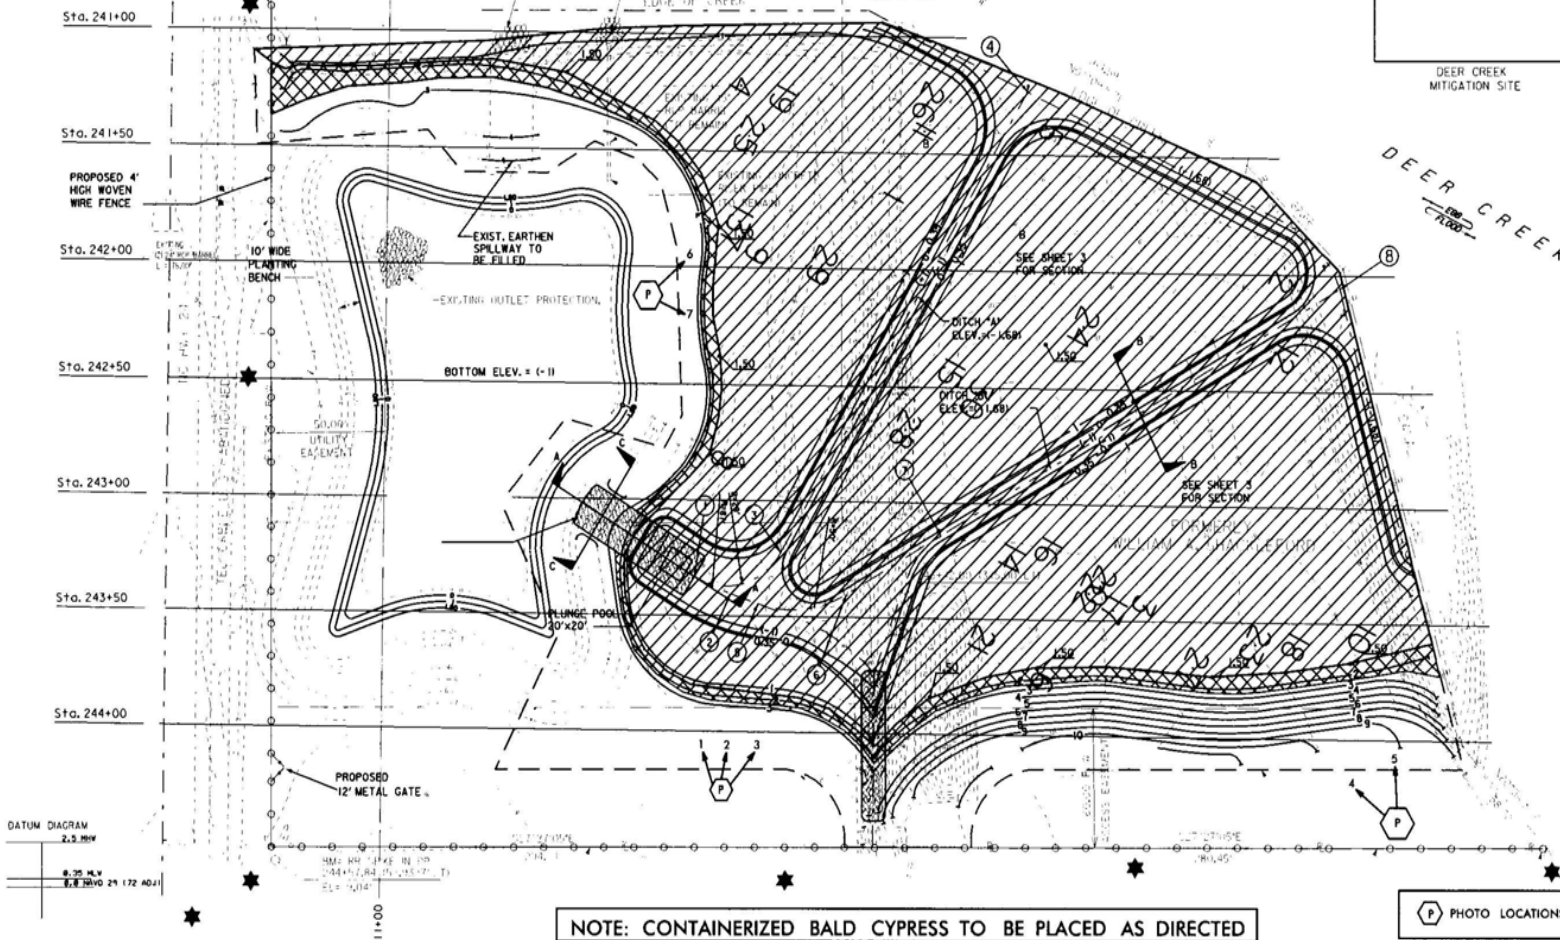
## DEER CREEK MITIGATION SITE RANDOM PLOT AND PHOTO LOCATIONS

# MARSH PLANTING (APP. 1.7 ACRES)

SPARTINA ALTERNIFLORA
-

SPARTINA PATENS
-

RANDOM PLOTS
